TAG. Ball sometimes falls into bottom of cabinet instead of lodging in Tracy Island lift mechanism.

Application: All machines.

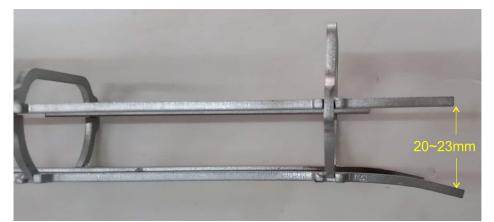
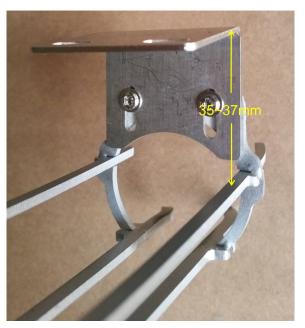
Confirm the bend on the ends of the frame as well as the adjustment height of the mounting bracket conforms to the following pictures.

Lift the playfield and remove the subway wireform (3 screws).
